Sinkhole Back-filled with Stone

Open Cut Solutions. Quick and Safe with Minimal Disturbance.

During the early spring of 2011, in the Village of Oak Park, Illinois, a bulkhead used to seal the “future use” stub of an 8.5-foot combination storm water and sanitary sewer failed. The failure of the bulkhead allowed the subgrade soils and pavement base course material to enter a sewer junction chamber, creating a sinkhole measuring approximately 12 feet by 20 feet by 24 feet deep in the pavement area. The intersection is located adjacent to a large high school and must accommodate heavy pedestrian and vehicle traffic prior to and after the school day. As an emergency measure, the affected area was back-filled with approximately 12 feet of CA-07 and 12 feet of CA-06. Both “open cut” and “no dig” solutions were considered for the repairs.

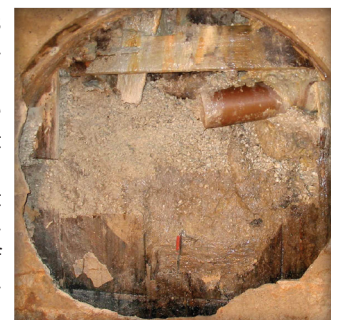
Grouted Soil Mass

Slurry grouting to stabilize the sinkhole backfill was accomplished prior to removal of the soils and aggregate material that entered the sewer through the failed bulkhead. Nine 2-inch grout pipes were driven to depths ranging from 12 feet to 24 feet into the sinkhole backfill. Each pipe was then lifted approximately 4-inches prior to injecting the first stage of grout. Subsequent stages varied in thickness between 1 foot and 2 feet. The quantity of grout injected for each stage ranged from 10 gallons to 140 gallons. Both the stage thickness and

grout quantity were dependent on backfill material, proximity to the failed bulkhead, and void volumes in communication with the grout stage.

The grout was mixed onsite and pumped using a ChemGrout CG-500 portable batch plant. During the slurry grouting the ground surface and pavement surrounding the injection site, as well as the visible surroundings of the failed bulkhead, were visually monitored. Grout injection was stopped when any stage caused inflow of grout to the inside of the sewer through the failed bulkhead or if grout seepage was observed at the ground surface. Grout inflow through the failed bulkhead was observed during 14 of the stages and surface seepage was observed during 2 stages.

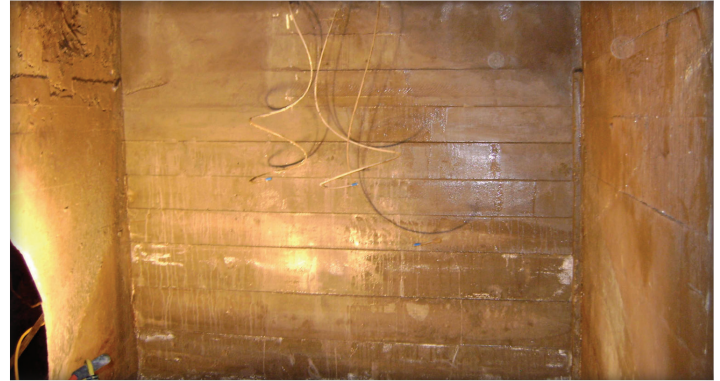
Formed Concrete Bulkhead with Injection Tubes

The bulkhead concrete was placed by pumping and allowed to attain the 4000 psi design strength prior to form removal. The junction chamber, where the bulkhead was placed, is scheduled to be epoxy coated following a 28-day cure period. the project.
